Bicycle Safety in Gothenburg

A case study of bicycle – motor vehicle collisions on one- and two-way cycle paths at intersections

Master of Science Thesis in the Master's Programme Infrastructure and Environmental Engineering

Department of Civil and Environmental Engineering Division of GeoEngineering Road and Traffic Research Group CHALMERS UNIVERSITY OF TECHNOLOGY Göteborg, Sweden 2014 Master's Thesis 2014:44

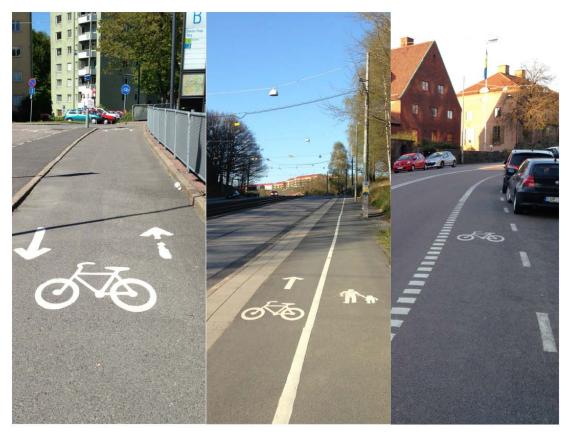
Figure 1. Two-way cycle path, one-way cycle path and a cycle lane.

Cycle infrastructure has different layout forms and to clarify terms used in this report a short description is provided here. Figure 1 shows a one-way cycle, two-way cycle path and a cycle lane.
